## SERVICE BULLETIN

# Periodic inspection of the float buoyancy for ROTAX® Engine Type 912 and 914 (Series)

ATA System: 73-00-00 Fuel system

### MANDATORY

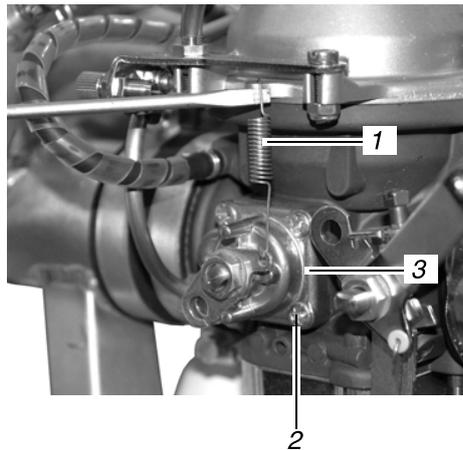
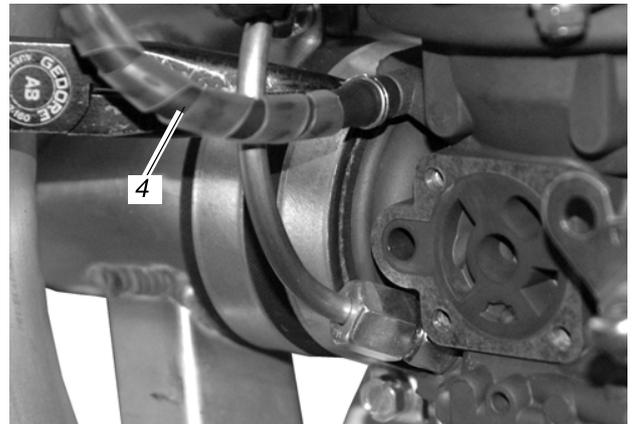
*Fig. 1*

- 1 Return spring
- 2 Philips head screw M4x14
- 3 Rotary valve housing
- 4 Air vent line

Step	Procedure
1	Bring the float chamber to horizontal position (level the aircraft, if necessary).
2	Let the engine idle for approx. 1-2 minutes. <b>NOTE:</b> Switch OFF the electric fuel pump (at 912 Series).
3	Remove the return spring (1).
4	Remove 4 Philips head screws (2). Remove rotary valve housing (3) with the gasket.
5	Remove the air vent line (4). Installed steel line must not be removed.

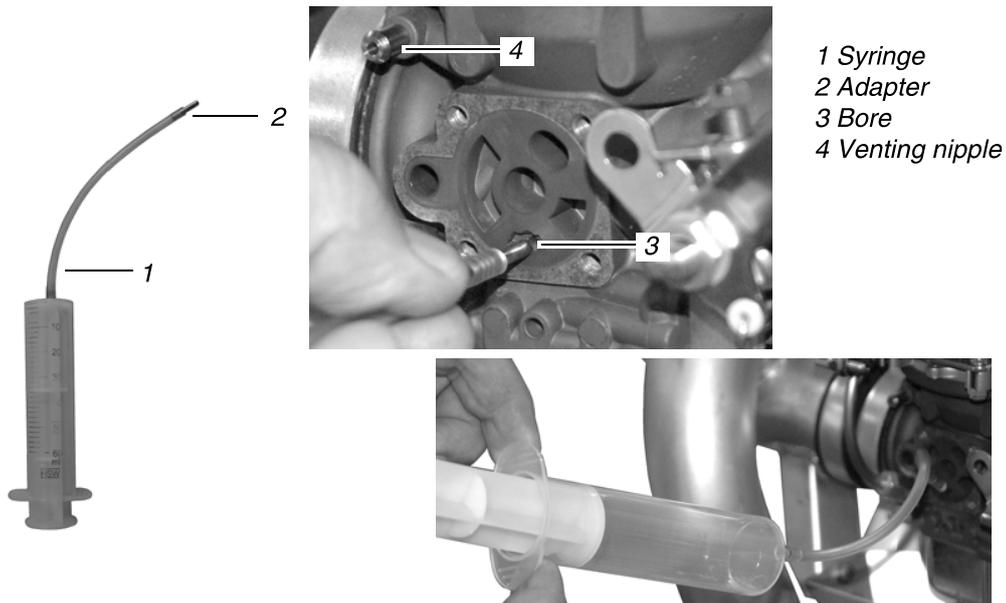
Fig. 2

Filling volume in float chamber	Evaluation
23 ml - 40 ml	Floater are OK, the float level is within the limit.
less than 23 ml	Significant deviation of the float levels. A detailed inspection of the floaters or their weight is necessary. See section. 3.5).
more than 40 ml	Significant deviation of the float levels. Repeat inspection to avoid incorrect measurements. See section 3.1.1). A detailed inspection of the carburetor and floaters or their weight is necessary. See section. 3.5). Check float needle valve for any leakage and setting of the float bracket.

Step	Procedure
1	Fill the syringe (1) with 40-50 ml amount of fuel.
2	Connect syringe with the adapter (2) using a transparent fuel hose
3	Fuel hose and adapter must be free from air bubbles.
4	Insert the adapter (2) in the lower bore (3) of the rotary valve. Ensure a firm fit.

During the following inspection of the volume, carefully fill the float chamber with a syringe until the fuel leaks from the venting nipple (4). This process should take about 5 seconds. Record capacity before the filling operation. The capacity can be determined by reading the scale of the syringe.

Step	Procedure
5	Fill the float chamber until the fuel leaks from the venting nipple.
6	Determine the volume.
7	Perform the same inspection on the second carburetor.
8	The results of the measurement must be documented in the maintenance records.

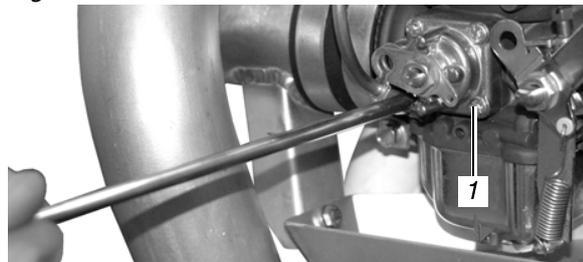
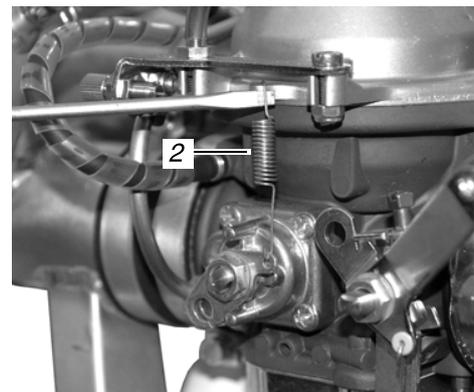
Fig. 3

1 Philips head screw 4x14  
2 Return spring

Step	Procedure
1	Install the venting line.
2	Install rotary valve with new gasket.
3	Secure first 2 threads of the Philips head screw 4x14 (1) with LOCTITE 243.
4	Install the return spring (2).

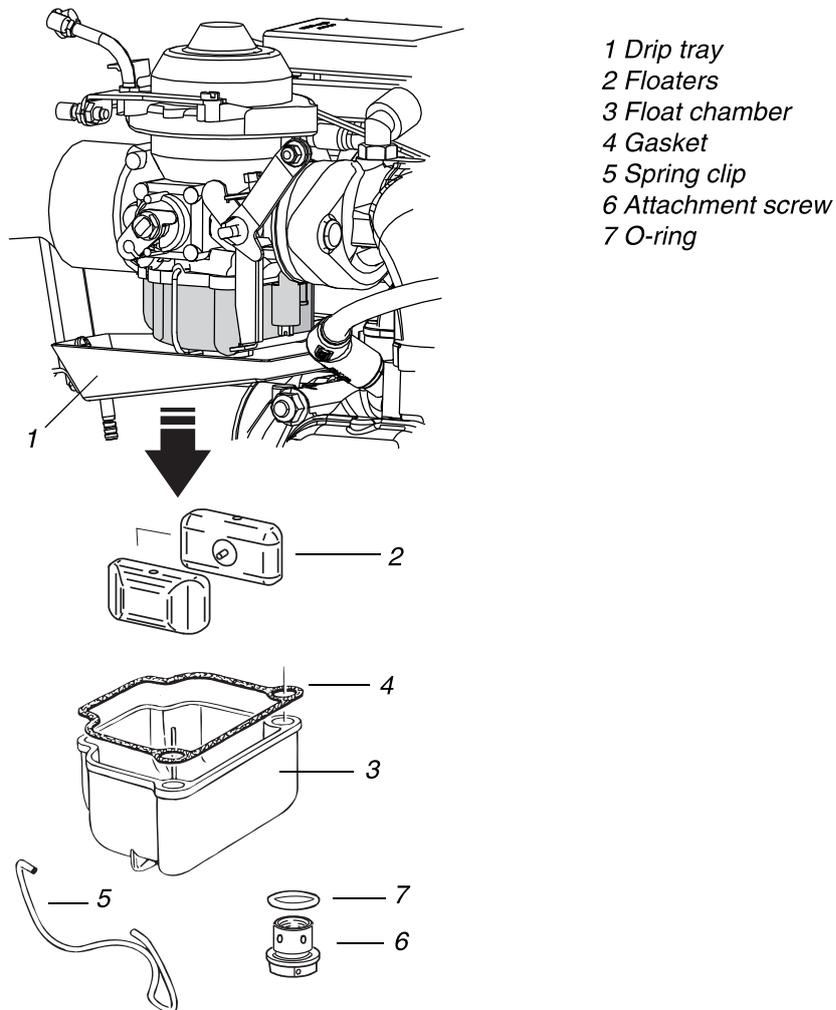
Fig. 4

If the inspection of float buoyancy section 3.5) shows a deviation, a weight control according to section 3.2) is necessary. For this purpose, as described below, the float chamber has to be dismantled.

Step	Procedure
1	Let the floaters dry for 1-2 minutes. Only balance dry floaters.
2	Check the weight of all affected floaters using a calibrated balance (1). Measuring tolerance of the balance: max. 0.1 grams.
3	The results of the measurement must be documented in the maintenance records. The max. allowable weight (of both floaters) is 7 grams.

Step	Procedure
1	Remove drip tray (1).
2	Visual inspection of the carburetor and its mechanical actuation.
3	Remove spring clip (5) and for ROTAX 914 Series loosen cap screw (6) and remove with O-ring (7).
4	Remove float chamber (3), gasket (4) and the two floaters (2)

Renew all floaters which exceed the max. weight.

Step	Procedure
1	Remove the gasket (4) from the float chamber and for ROTAX 914 Series remove the O-ring (7).
2	Install float chamber (3) with gasket (4) and the both floaters (2).
3	Close spring clip (5) or for ROTAX 914 Series install the attachment screw (6) including O-Ring (7). Tightening torque of attachment screw 5.5 Nm (48.7 in.lb).
4	Install drip tray (1).
